# ***Is 4253 finished yet? No, not yet!***

*... here's what's left to do*

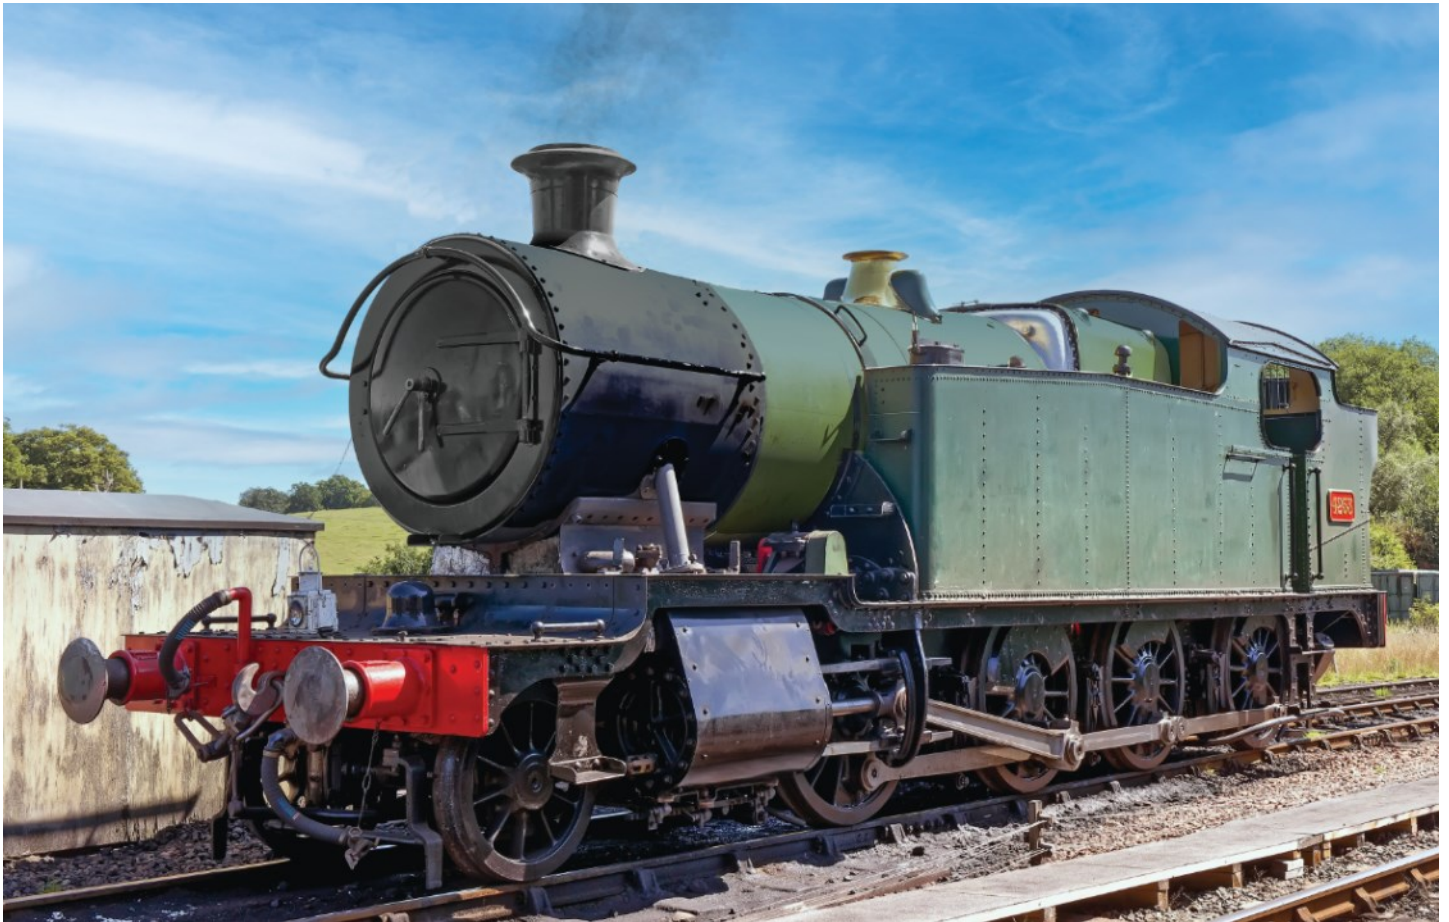
4253 out in the sunshine earlier this year.

After months of measuring, cutting, more measuring, more cutting, and a lot of 'choice' words, the cladding was added to the boiler and firebox. We then trial fitted the water tanks and cab roof to ensure everything fitted nicely.

Now don't be deceived, the photo above shows what appears to be a complete locomotive. In truth, it is 90% (+/-) complete. There is still a lot of pipe work to be installed together with the ashpan, and the 'elephants' ears' (cladding that goes between the boiler barrel and the firebox).

Once we are happy with how it all fits together, it will be completely taken apart again, to allow the boiler to be removed for its steam pressure test. On passing this, the ashpan will be fitted and the boiler repositioned within the frame. We will then rebuild the locomotive for

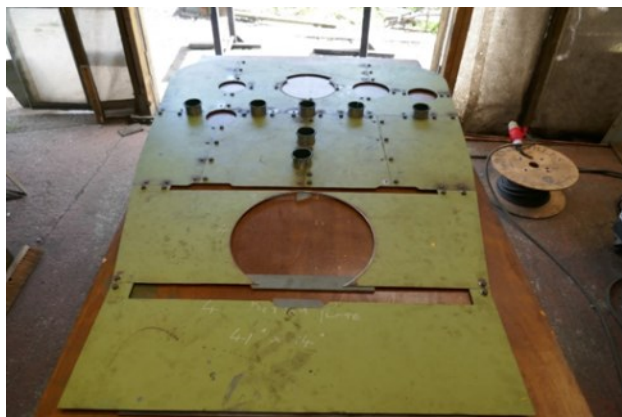
Another major item in the cab is the complicated back plate 'cleating' that goes behind the controls. This took many hours to measure, cut and reconnect, using a combination of rivets and bolts to allow the many sections to be slotted behind the controls and to allow for removal if necessary when the loco is in service.

This will all need to be taken apart and removed before the steam test and then insulation wrapped around the fire box. It will then all need painting and reassembly before any controls or gauges can be put back on. Trial fitting of the back plate cleating components is shown on the right.
