Railcar W20W Restoration Project: The story so far Progress Report

The protracted restoration of the 1940 Railcar W20W on the Kent & East Sussex Railway received an important boost in 2022, with the award of a £20K grant from the A.I.A. With this grant, the resulting launch of the “20 for 20” public appeal and the matched funding by the railway itself, the long hoped for return to traffic of this precious and historically significant vehicle became a real possibility.

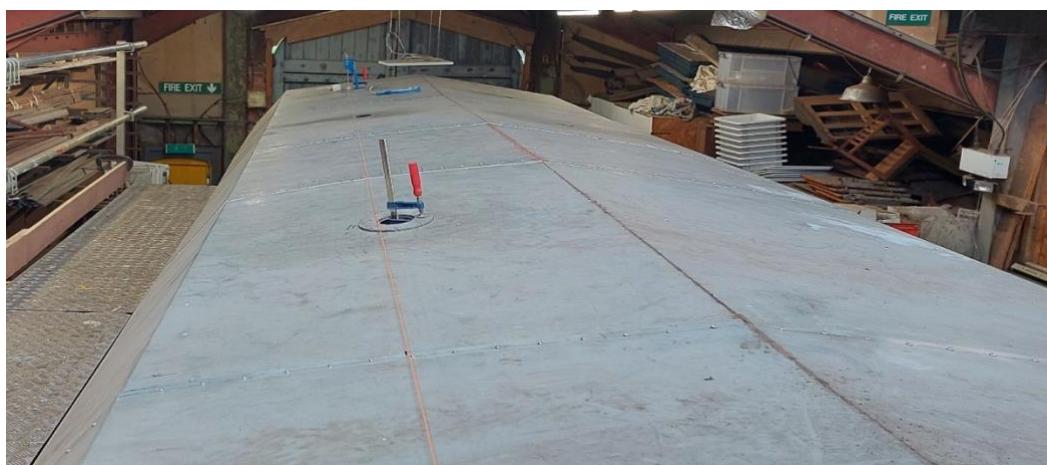
Above: Early roof sheet replacement in progress

To achieve this initial objective, the main areas to be progressed were the roof and the saloon glazing. The roof sheets had been fabricated many years ago and were only lightly affixed onto the internal roof trusses. These were permanently fitted with the vent holes cut out during the Autumn of 2022 and then the roof was painted.

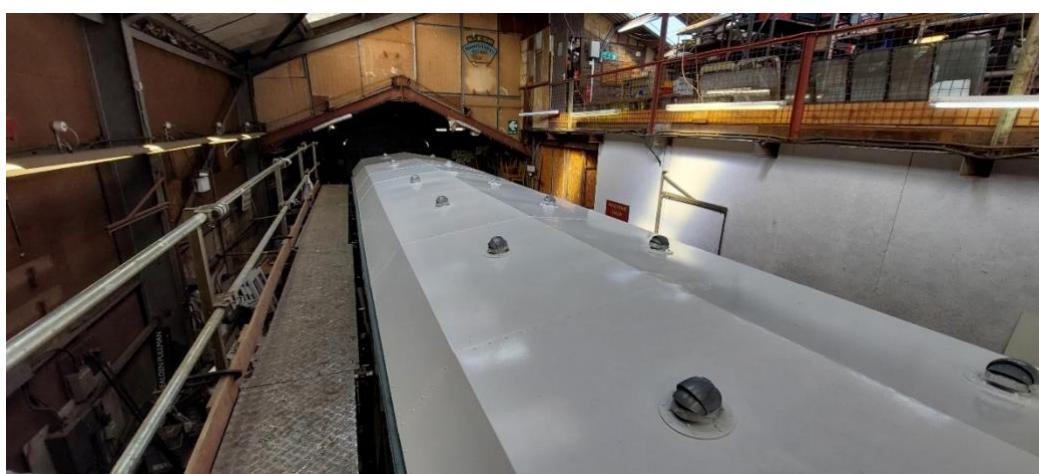
Below: the finished look

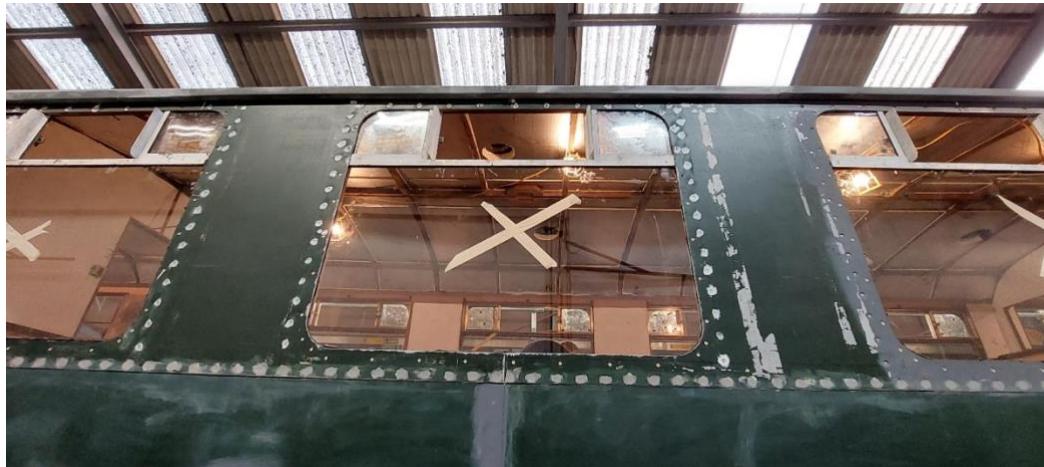
Large saloon glazing. Note the countersink holes, all of which needed to be filled and sanded

The full set of glazing was also installed in the two saloons and the luggage compartment. However, the cab glazing had to be put on hold until later in the programme, due to the cab sheet metalwork needing to be prepared and fitted first.

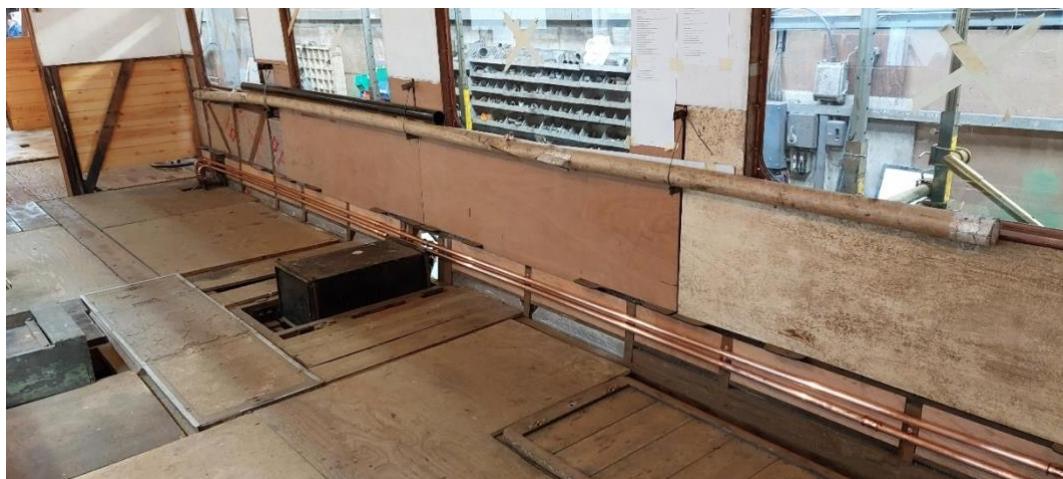
New pipework installed within the large saloon, replicating the old heat pipe layout

A new diesel-fired hot water system was developed, commissioned and installed. The installation was designed to replicate as near as possible the original arrangement with the existing heater cabinet being used to house the new units and the pipework following the original steam-heat pipe runs. With the heating installation completed, attention could move on to the flooring.

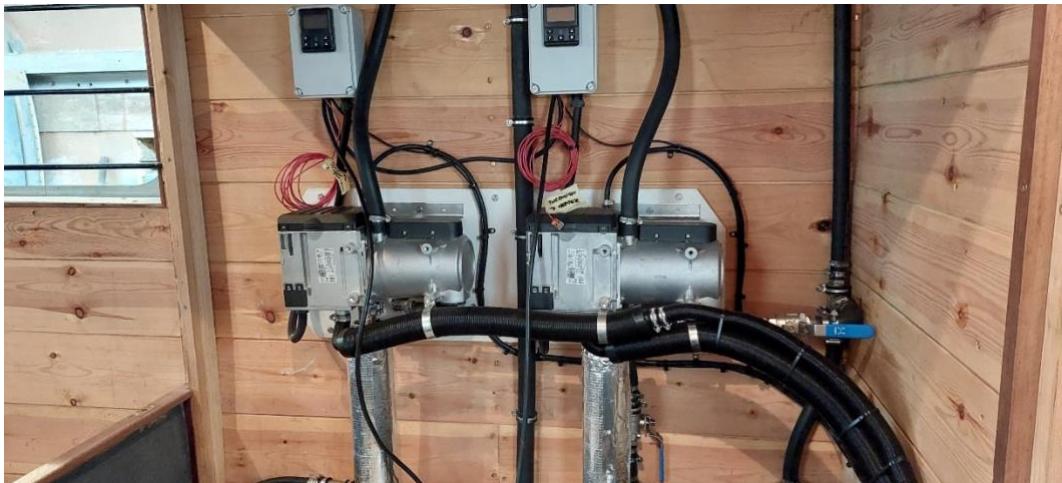
New diesel-fuelled heaters mounted within the original heater cabinet

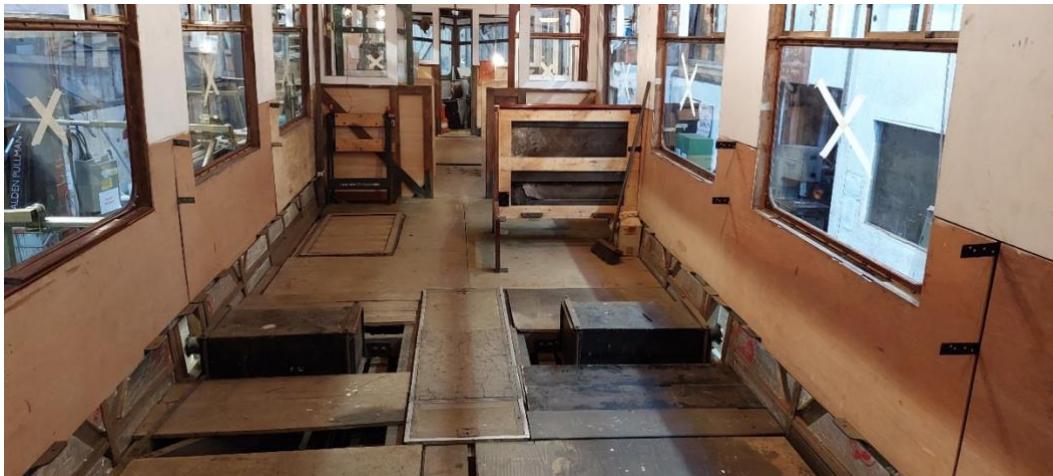
Above: the temporary floor awaiting replacement

The Independent Competent Person (I.C.P.), appointed to oversee the restoration of the vehicle approved the various flooring layers to ensure full fire and safety compliance. Initially just the load-bearing layer was fitted, utilising 18mm buffalo board. This left the fire/soundproof layer and top decorative finishes for later installation.

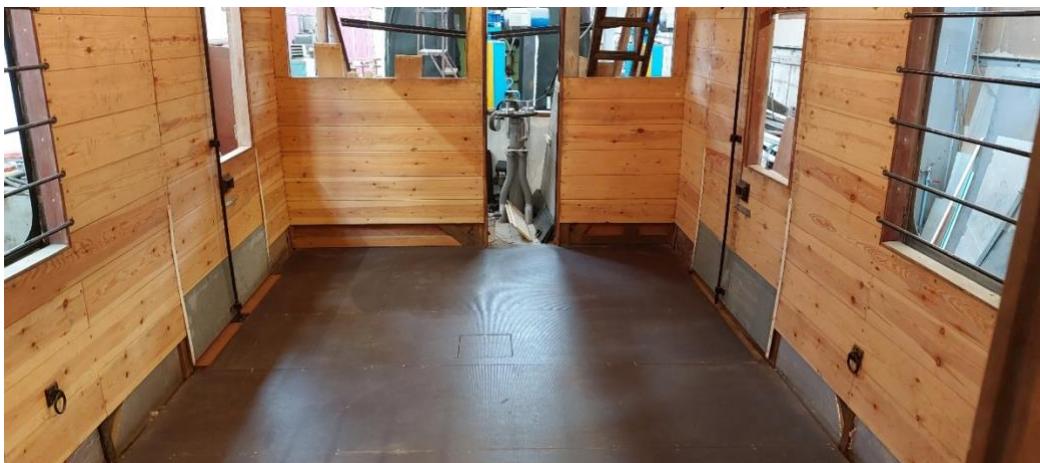
Below: The replacement structural floor installed within the Luggage compartment

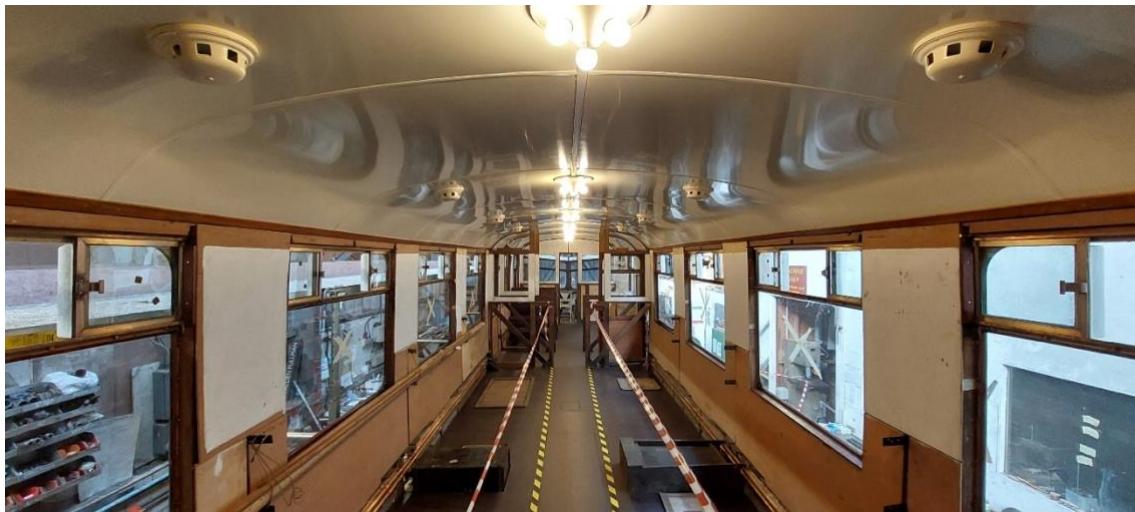
Main section of ceiling panels installed with the original vents and lighting clusters fitted

The rest of the interior could now be progressed including: the roof insulation; ceiling panels; light fittings with their associated wiring; the saloon side panels with the leathercloth covering, and the luggage racks.

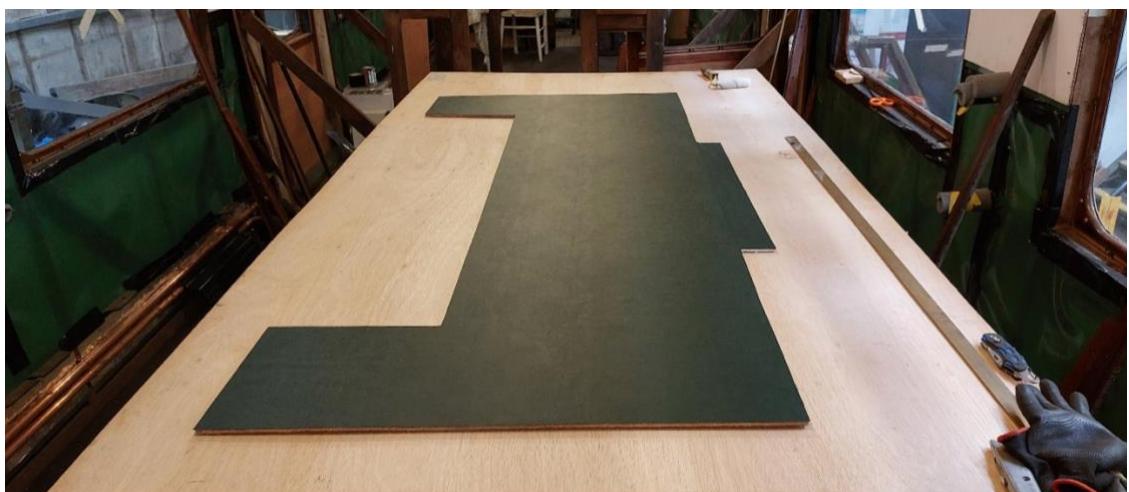
Leathercloth applied to side panel ready for fitting

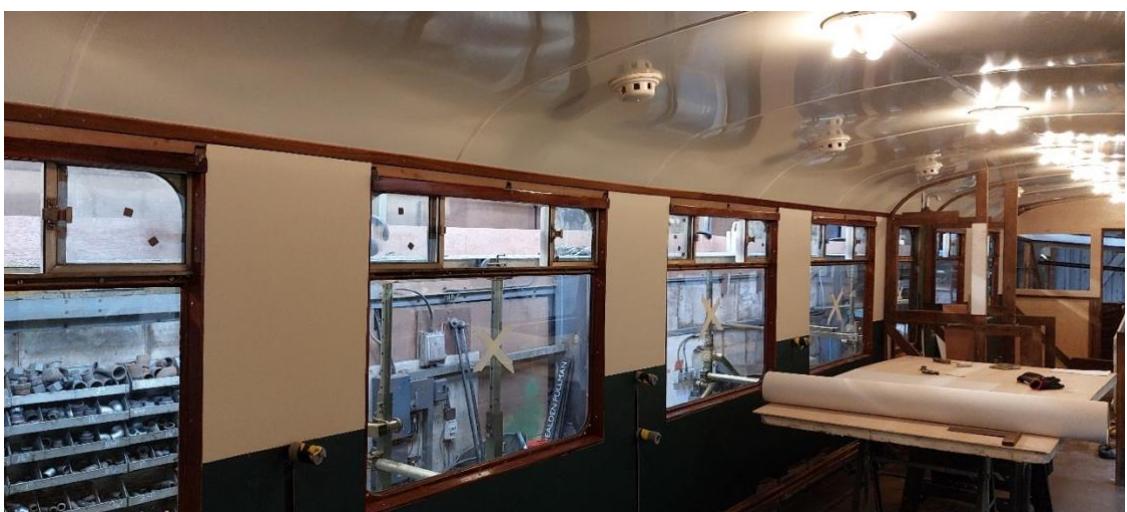
The cream upper and green lower leathercloth panels fitted within the large saloon

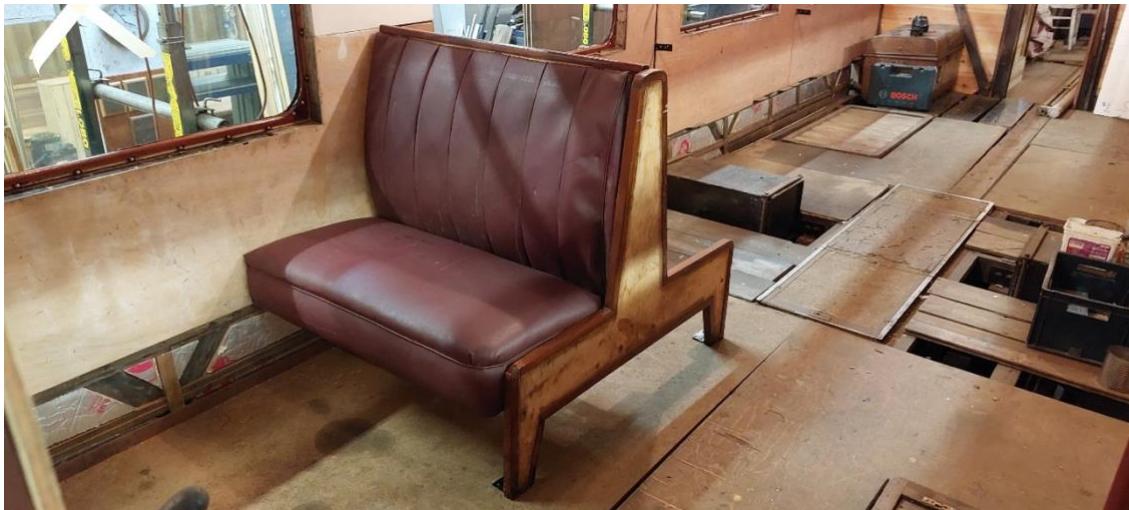
The existing seats, with the incorrect leatherette covering and non-compliant horsehair filling

The next major task was the restoration of the seating. These had been covered in an inappropriate leatherette material many years previously. It was important to re-cover these with an appropriate moquette. Fortunately, a manufacturer was identified who could supply the genuine, original material. The moquette was obtained and both it and the seat frames were sent away to a specialist contractor for full renovation and re-upholstering to modern safety standards.

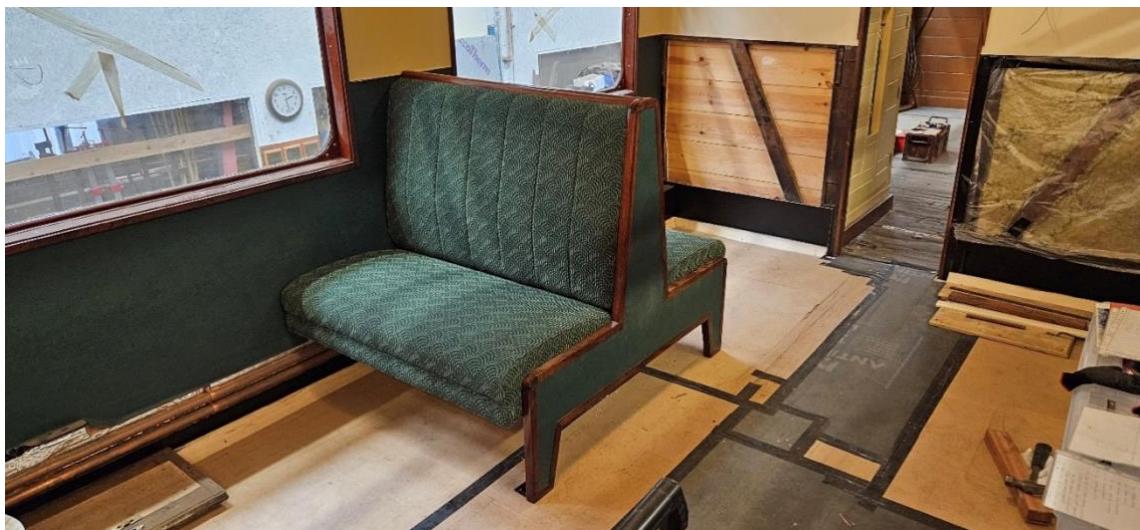
The renovated and re-upholstered seating being trial fitted on their return from the contractor

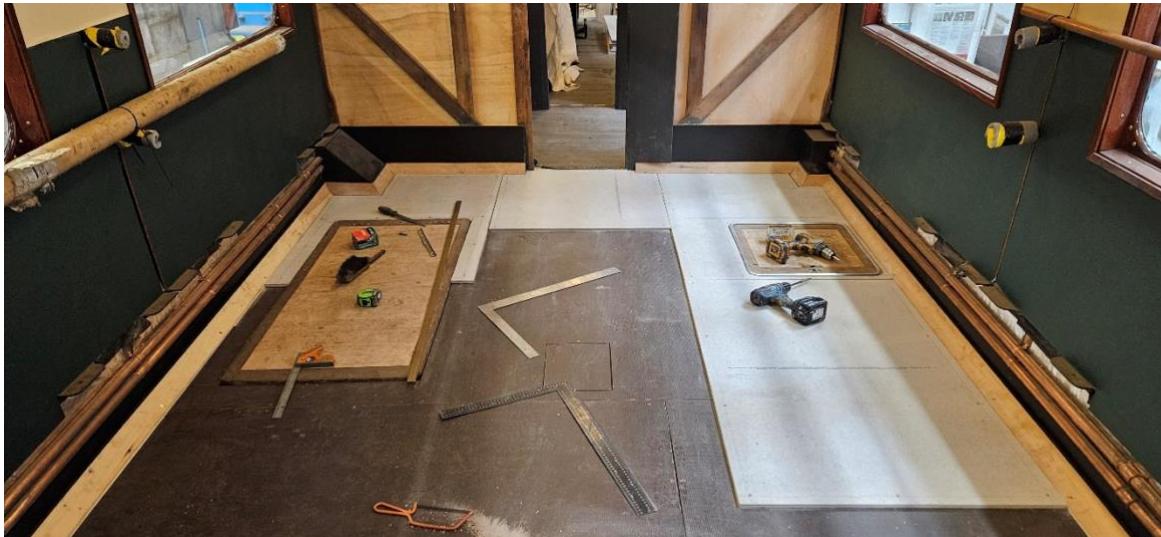
The fire/sound proof layer being laid over the structural floor within the large saloon

Before the seating could be permanently installed, the flooring needed to be completed. This entailed laying the fire/soundproof layer followed by the final top finishing. The finish would be brown Marmoleum (lino) in the luggage compartment with green in the large saloon and a contemporary style carpet in the small saloon.

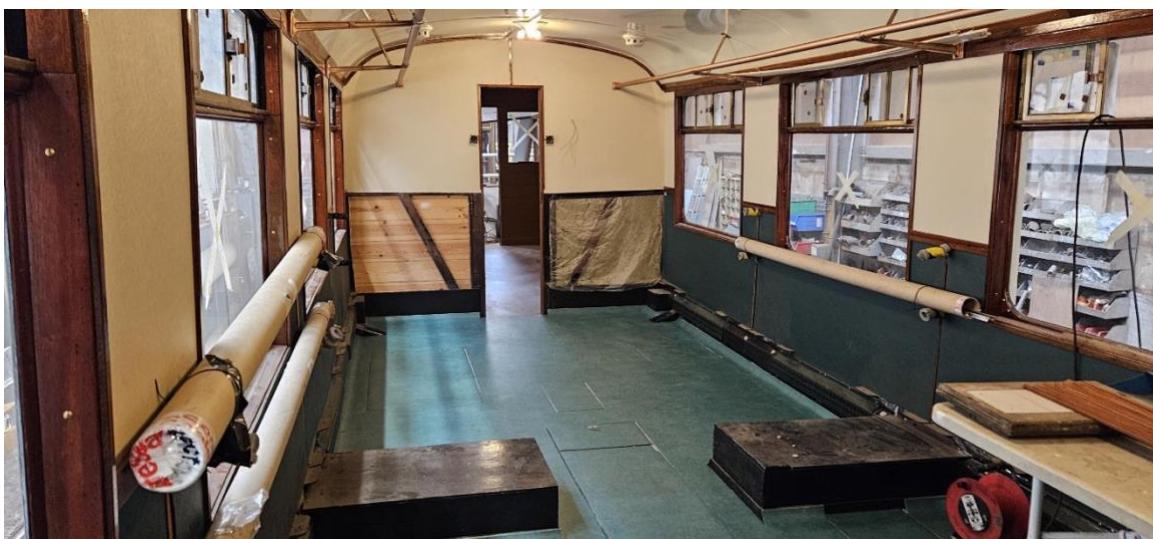
Green Marmoleum laid in the large saloon, just awaiting the seating

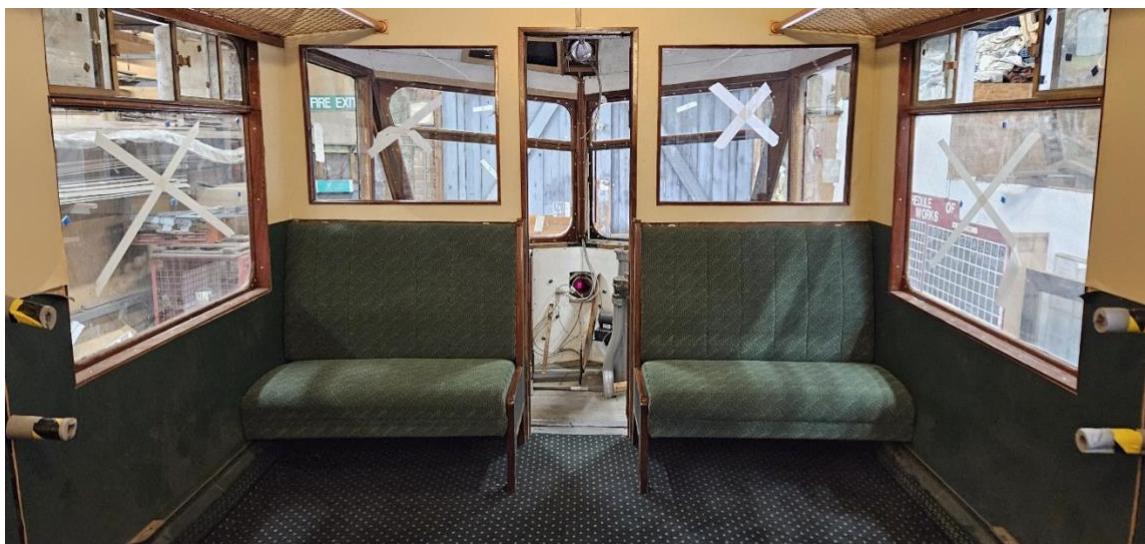
Seating installation progressing in the small saloon with the green carpet in place (Also visible are the fitted restored luggage racks)

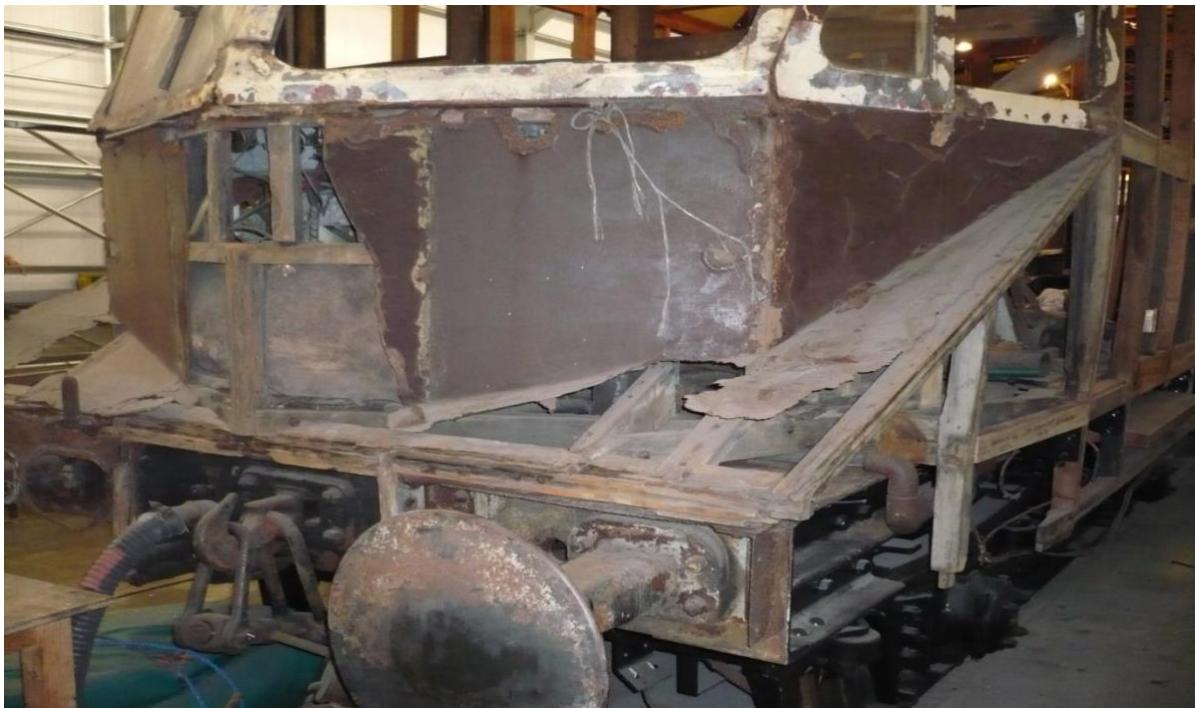
The next task was to address one of the last major issues of the restoration: the cab sheet metalwork. For many years various attempts had been made to reconstruct the very badly deteriorated existing cab metalwork. Unfortunately, due to the complex nature of the cab construction, these attempts had proved unsuccessful.

Badly corroded state of the cab metalwork before reconstruction

With the aid of the A.I.A. grant it was decided to commission an experienced vehicle restoration sheet metalworker, welder and fabricator. Over a period of a few months both cabs were fully re-built, enabling the project to take a big step forward.

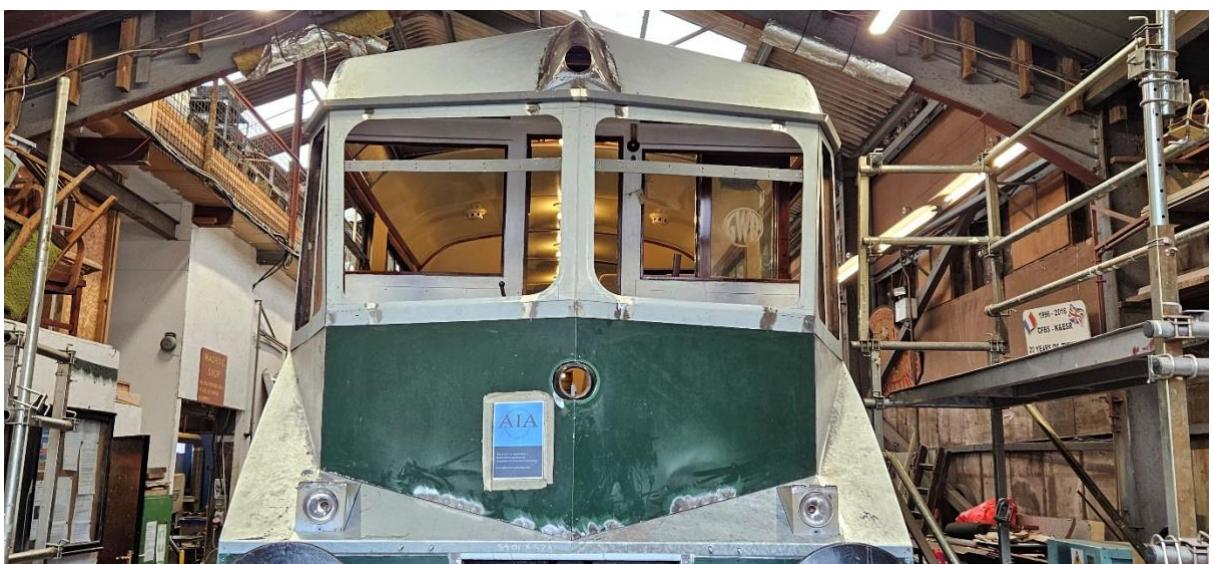
Robertsbridge cab reconstruction in progress

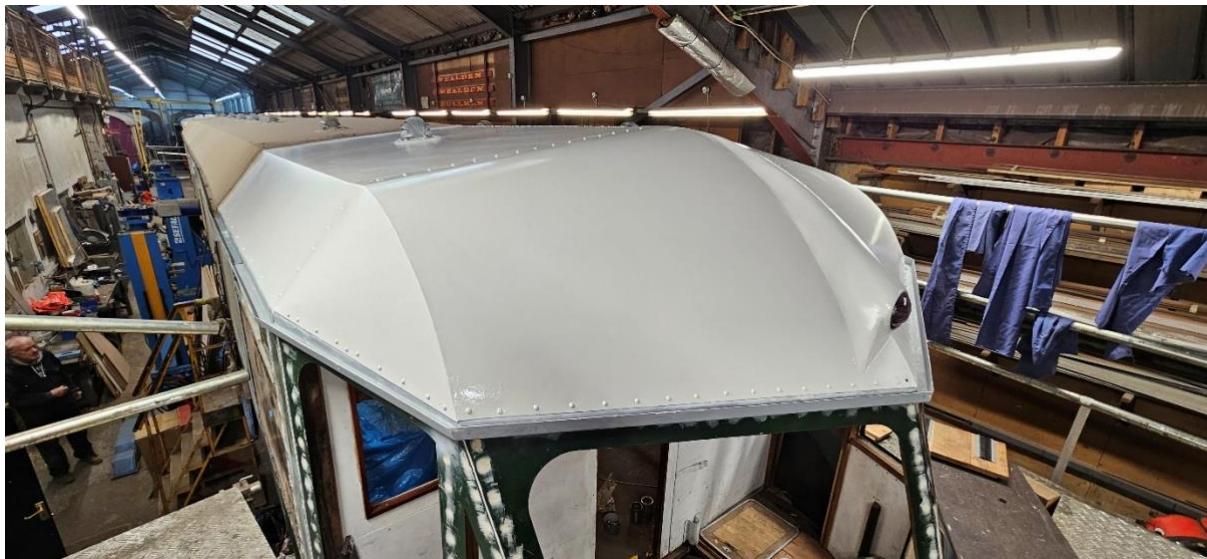
Completed dome (Robertsbridge end)

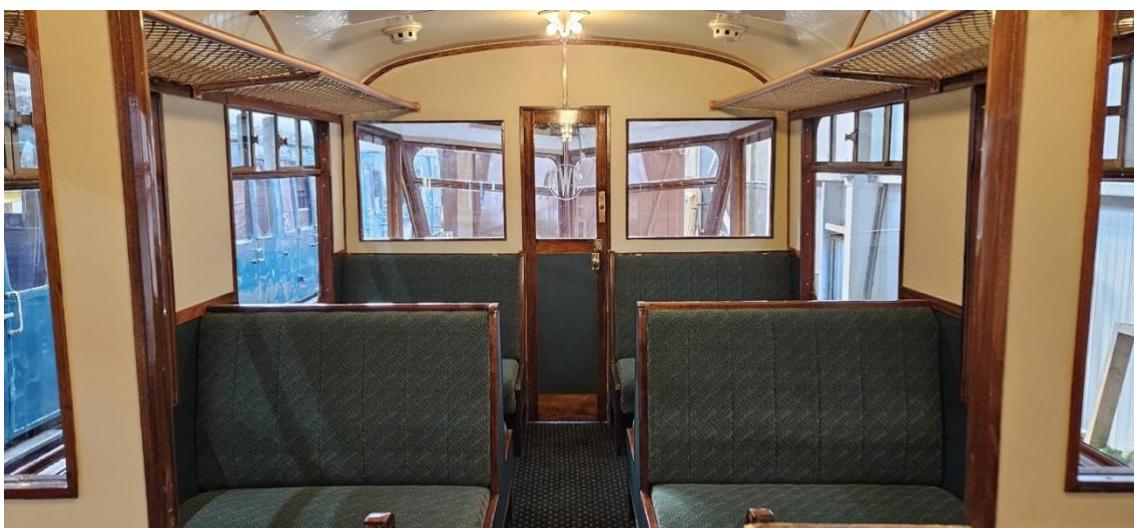
The completed small saloon

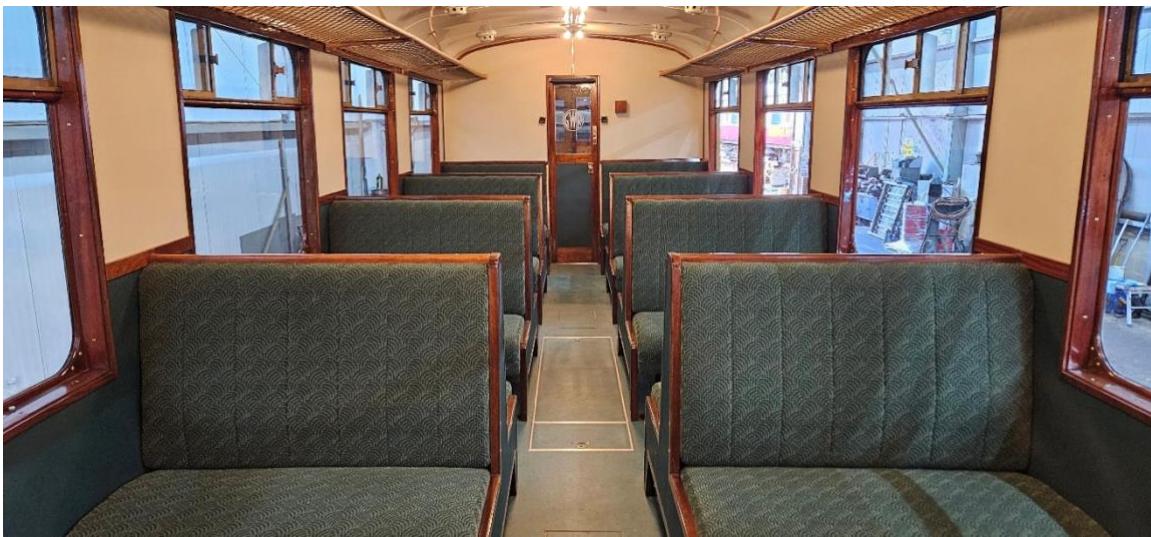
The large saloon is also looking resplendent

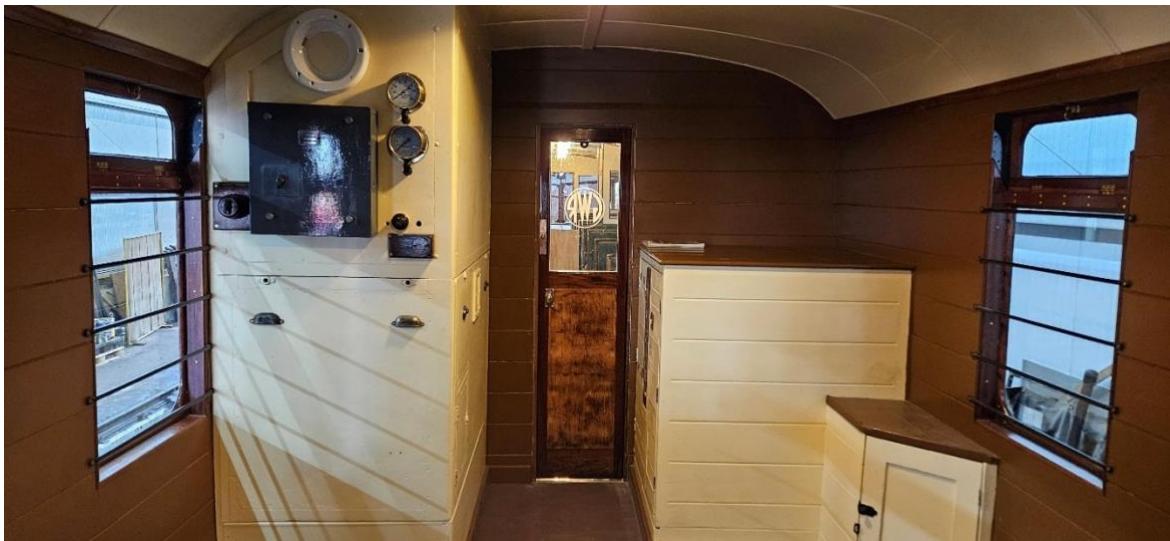
The luggage compartment is nearly completed, but wheelchair anchor points still to be fitted
